GAO

PROCUREMENT

Quality and Safety Problems With the Beretta M9 Handgun

B-222372

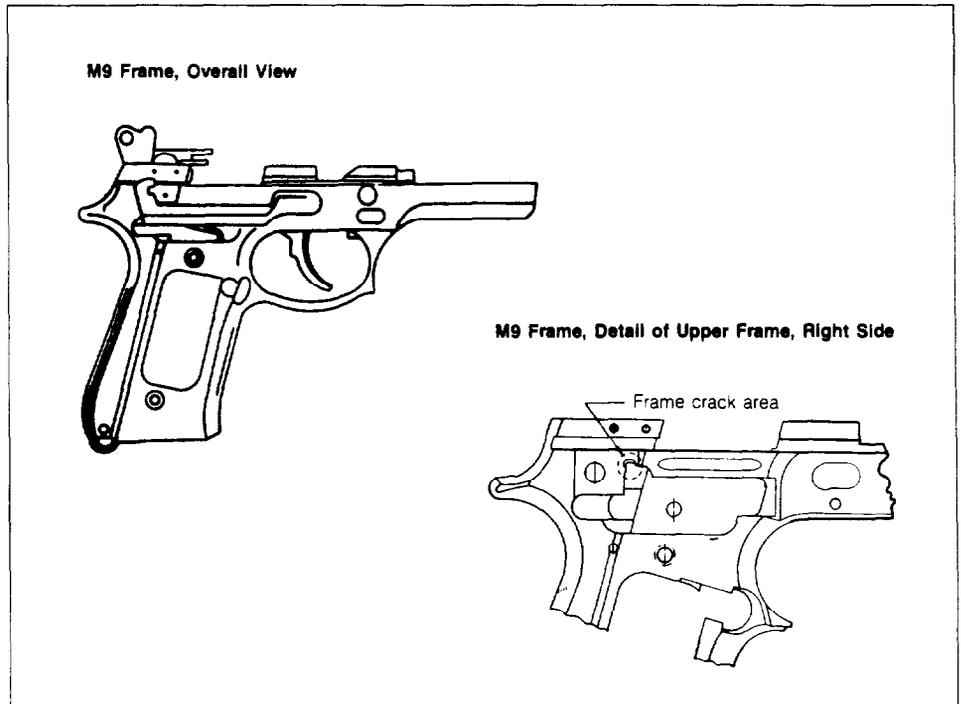
Figure I.2: M9 Frame and Location of Frame Cracks

The Army considers the frame crack problem to be cosmetic in nature with no adverse effect on the weapon's performance or reliability. Nevertheless, the frame cracks violate acceptance testing procedures specified in the contract and were the reason the Army rejected the December 1987 and January 1988 production lots, totaling about 12,000 M9s. An engineering change proposal (ECP) has been implemented to correct the problem, and the previously rejected M9s have been reworked, tested, and accepted by the Army.

Indications of frame cracks were first noticed during lot production testing of the M9s produced in September and October 1987. At that time, the DCAS representative at the Beretta plant recommended that the Army not accept the lots, which totaled about 12,000 weapons. However, the M9 program office overruled the recommendation on the basis that it was not clear that the frames were cracked. In the program office's opinion, what looked like cracks in the frame could have been surface marks or scratches.

Production lot testing of the November 1987 lot did not indicate any frame cracks. However, frame crack indications reappeared during the December 1987 and January 1988 lot testings. In response to these test results, the Army rejected the two lots. Figure I.2 shows the location of the frame crack. (See app. III for a detailed description of quality conformance lot and acceptance inspections.)

In February and March 1988, the contractor continued to produce M9s at the rate of 6,000 a month. However, these lots were not submitted for acceptance testing. Thus, at the end of March 1988, the Army had rejected 12,000 M9s and the contractor had not submitted an additional 12,000 M9s. During April 1988, an ECP was implemented to correct the frame crack problem. The ECP involved a design modification and associated machining to reduce the force transmitted to the rear portion of the frame when the weapon is fired.

According to the DCAS representative, as of August 30, 1988, the 24,000 M9s handguns in the December 1987 and January, February, and March, 1988, production lots had been reworked, tested, and accepted by the Army. The April 1988 production lot, consisting of 591 weapons produced before the ECP was incorporated and 5,409 M9s produced after the ECP was incorporated, had just been submitted to the government for testing and acceptance. We were told by the DCAS representative and M9 program office that no decision has been reached between the government and Beretta as to who will be responsible for bearing the cost of reworking the M9s produced before the ECP was implemented.

This modification outlined the manufacturing process, procedures, and engineering changes needed to eliminate the frame crack problem.

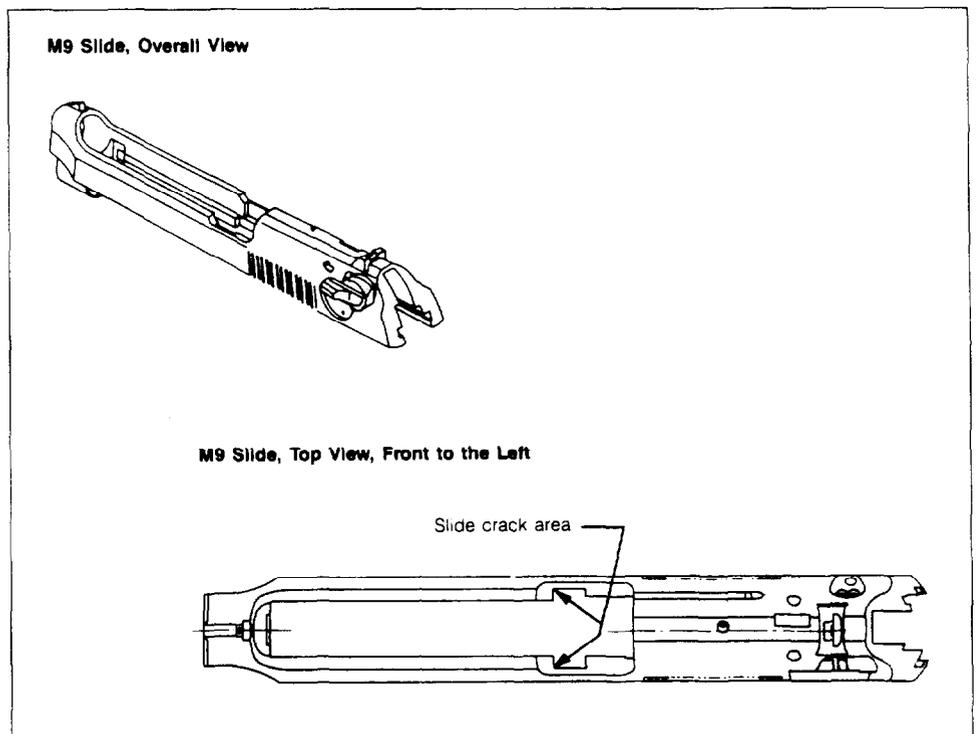
Figure I.3: M9 Slide and Location of Fatigue Cracks

Several Beretta 9-mm handguns experienced broken slides that separated from the weapon. The Army has determined that a fatigue crack located near the slide's locking lug slot causes the slide to break when it reaches its full rear firing position. (See fig. I.3.)

The Army considers the slide failure problem to be the more serious of the two recent weapon problems. The slide is expected to continue to function without cracks or breaks for at least 7,000 rounds, and as shown in table I.1, most of the weapons met this requirement. However, what is of particular concern to the Army is the unsafe manner in which the slide fails. When failure occurs, the slide breaks into two parts, and the rear part flies back at the shooter, possibly causing injury. As a result of the three operational failures and the first test failure, the shooters received injuries. Three shooters received face lacerations. One

The Army is also pursuing the root cause of the metal fatigue that causes the slide to fail. As part of its efforts to identify the cause of the fatigue cracks, the Army is reviewing the process for heat-treatment of the slides. Prior to April 1988, all the slides were manufactured in Italy. Since that time, the slides have been manufactured in the United States. The slides that failed were manufactured in Italy; however, the Army has not made a determination whether to review the heat-treatment process for these slides because the contractor is no longer using Italian manufactured slides. Instead, the process used by the U.S. contractor is being reviewed to determine if the process needs to be revised in order to preclude future failure.

The Army's current focus is to identify a means to ensure that, if a slide fails, the broken slide will not injure the shooter. According to the Deputy Program Officer, the Army has decided not to accept delivery of any more M9s, after the April production lot is accepted in late August or early September 1988, until a fail-safe mechanism is incorporated in the weapon. He said that the Army would probably resume accepting deliveries in January 1989.

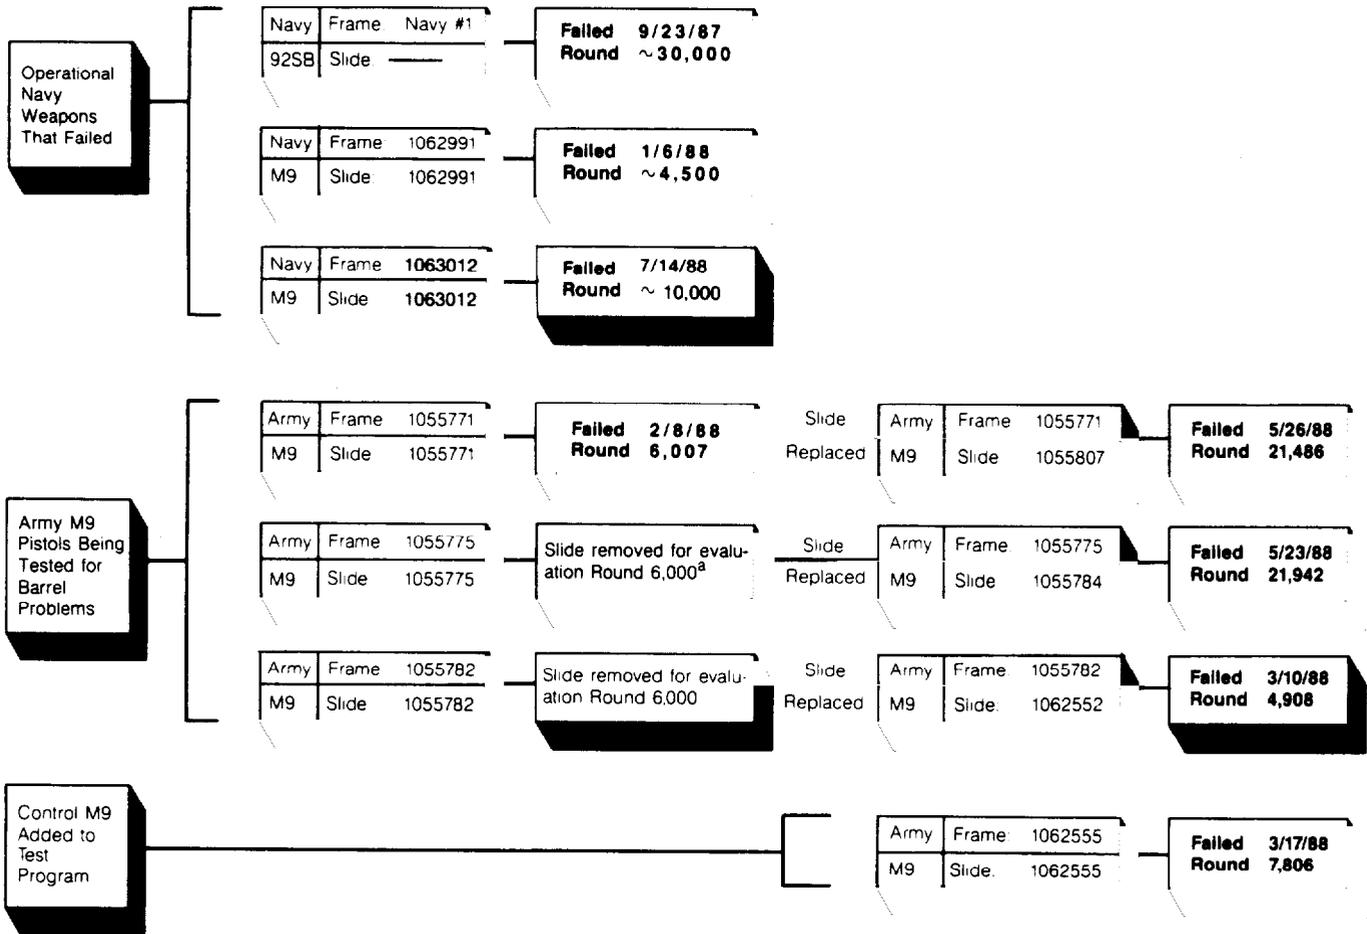
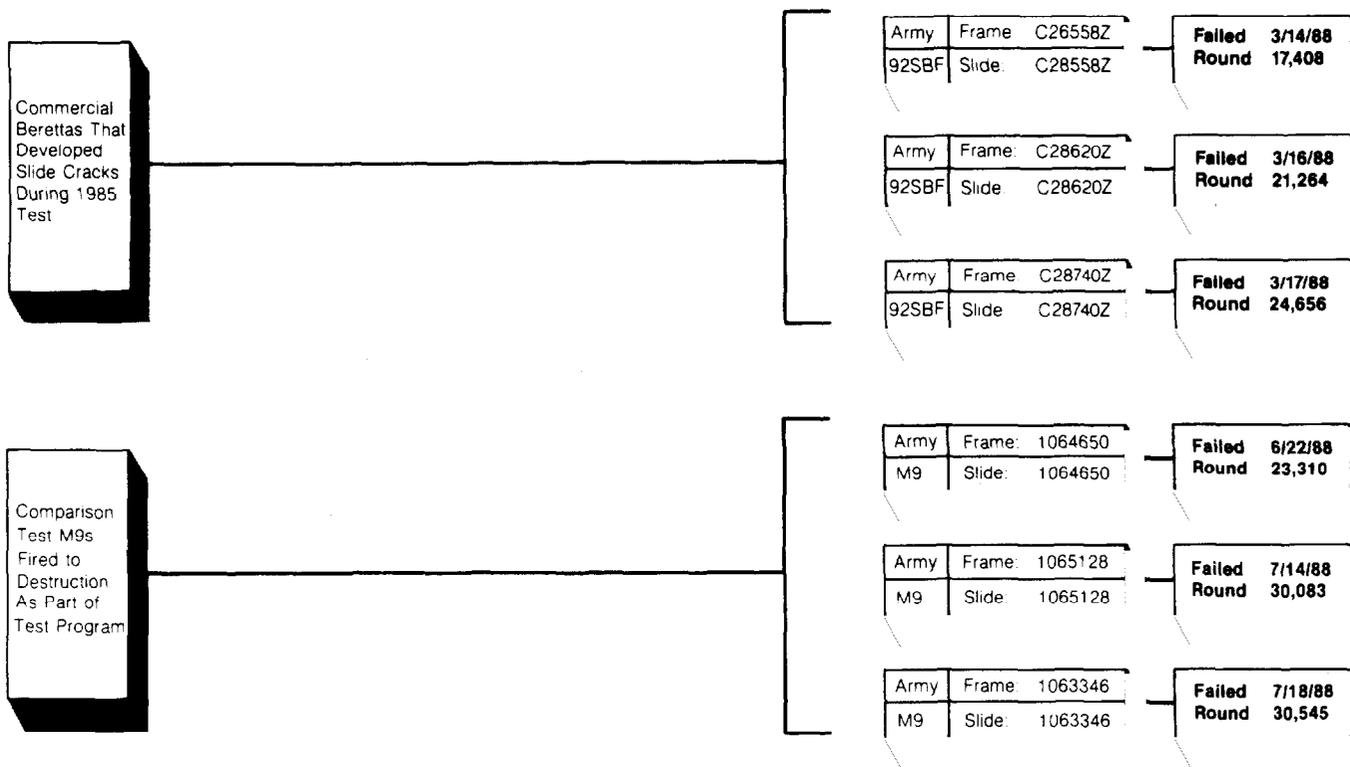
Figure I.4: History of the Slide Failures

Figure I.4 provides the dates and other details of each of the 14 slide failures.

^aCrack found after slide sectioned and inspected under microscope.

The first slide failure occurred on September 23, 1987, and the second on January 6, 1988. Both failures occurred in Navy operational units, and the actual number of rounds fired through the weapons is uncertain, because there was no requirement to keep a record of the rounds fired or of the ammunition that was being used. It is estimated that the first failure occurred after about 30,000 rounds and the second one after about 4,500 rounds. Until recently it was believed that other than North Atlantic Treaty Organization (NATO) standard ammunition had been used in these guns. However, based on additional information obtained by the Navy's Small Arms Program Manager, he believes that only the first weapon was firing non-NATO standard ammunition. The contract required that the 9-mm handgun be designed with the capability to fire NATO standard ammunition. However, the use of non-NATO standard ammunition in the M9 is not considered a breach of the contract or its warranty.

The third operational Navy slide failure occurred on July 14, 1988. It involved a field unit using an M9 firing NATO standard ammunition at the time of the failure. Although an M9 safety message recommended the slides be replaced after 3,000 rounds, the Navy estimated that this weapon had fired up to 10,000 rounds when it failed. The reason the safety replacement criteria was exceeded was that the unit had just returned from an operational deployment. The slide was scheduled to be replaced on July 25, 1988. Preliminary analysis of the failed slide showed that it had a low metal toughness similar to the slide failure that occurred February 8, 1988, after 6,007 rounds.

The first laboratory slide failure, which occurred on February 8, 1988, involved an Army M9 firing NATO standard U.S.-produced M882 ammunition. This weapon was one of three M9 handguns being tested for problems related to the barrel. As part of the test, all three weapons had been inspected after 6,000 rounds using a scanning electron microscope (SEM) or magnetic particle inspection (MPI) process, and there were no indications of slide cracks. When the M9 slide failure occurred at 6,007 rounds, the broken slide and the slides on the other two test weapons were removed for metallurgical evaluation. The evaluation showed that one of the other slides also had fatigue cracks. This evaluation marked the beginning of an Army slide failure test program to determine why the failures had occurred.

The next grouping of weapons in figure I.4 shows the test results for four other weapons: one M9 and three Army-owned commercial (92SBF) handguns. The slide on the M9 failed after 7,806 rounds, and the slides on the three 92SBFs failed at 17,408, 21,264, and 24,656 rounds. All the weapons were using NATO standard ammunition.

The final grouping of weapons involved three M9s that were being tested as part of an annual comparison test.¹ After the weapons were fired 10,000 rounds, the slides were inspected using the MPI process and one slide was cracked. The Army decided to fire all three weapons until the slides failed. Slide failure occurred at the 23,310 round mark on one weapon, 30,083 on another weapon, and 30,545 on the third weapon. Unlike previous slide failures, two of these failures occurred in a safe fashion. In other words, the slides did not separate from the weapons.
